Rehabbing O'Hare

Parking garage expansion-joints project is the largest of its kind in North America

By Doug Galinsky and Dave Bratek

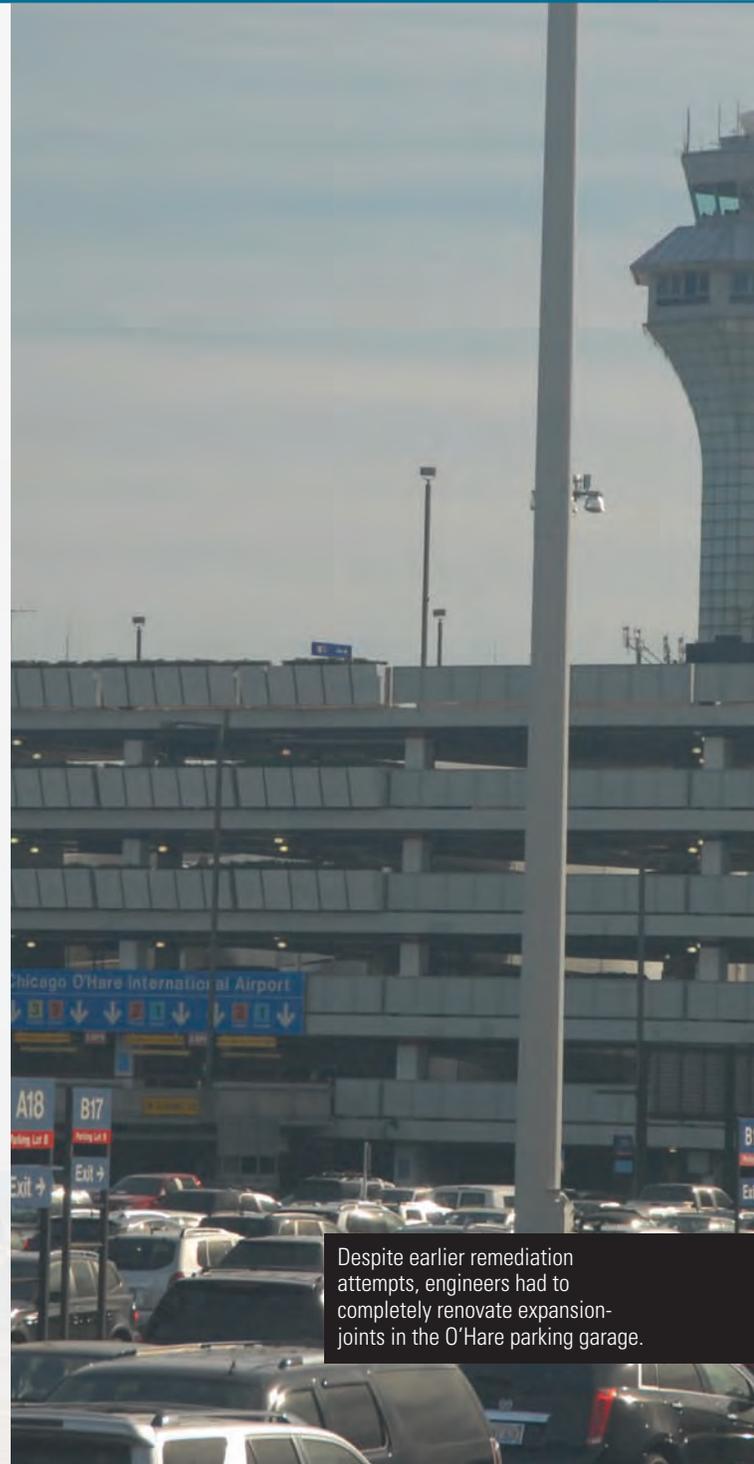
Despite earlier remediation attempts, engineers had to completely renovate expansion-joints in the O'Hare parking garage.

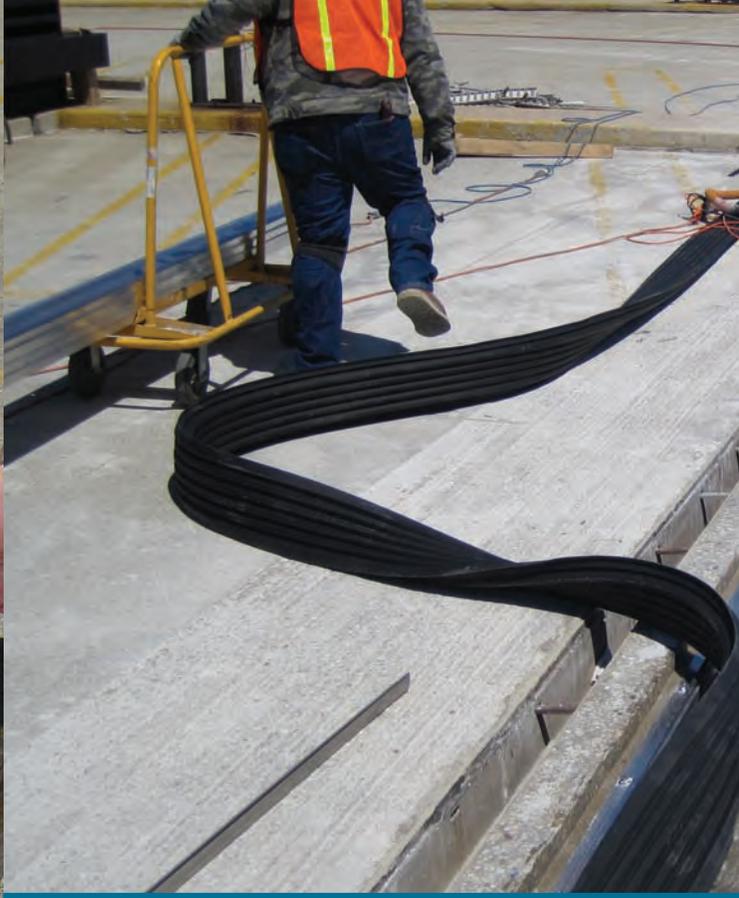
During evaluations in 2005 and 2006, engineers discovered one of the most detrimental aspects associated with the joints of the O'Hare International Airport elevated parking structure: water seepage. Water was leaking through failed expansion seals, behind the delaminating steel side plates and through cracks in new concrete segments at the joints (see photo, above). The water was contaminated from salt-laden snowmelt, deicing chemicals, road dirt and other impurities carried in by vehicles. The water also was contaminated by soluble salts in the concrete that dissolve in water as it flows through cracks in the new concrete.

By design, the original concrete deck sloped toward the expansion joints at all levels. Unfortunately, the slope directed all surface runoff to the joints. This contaminated water virtually cascaded down through the detached seals. The water that flowed in a more deliberate manner through the cracks even formed stalactites as it dripped on the level below.

The damage to seals was obvious after their removal.

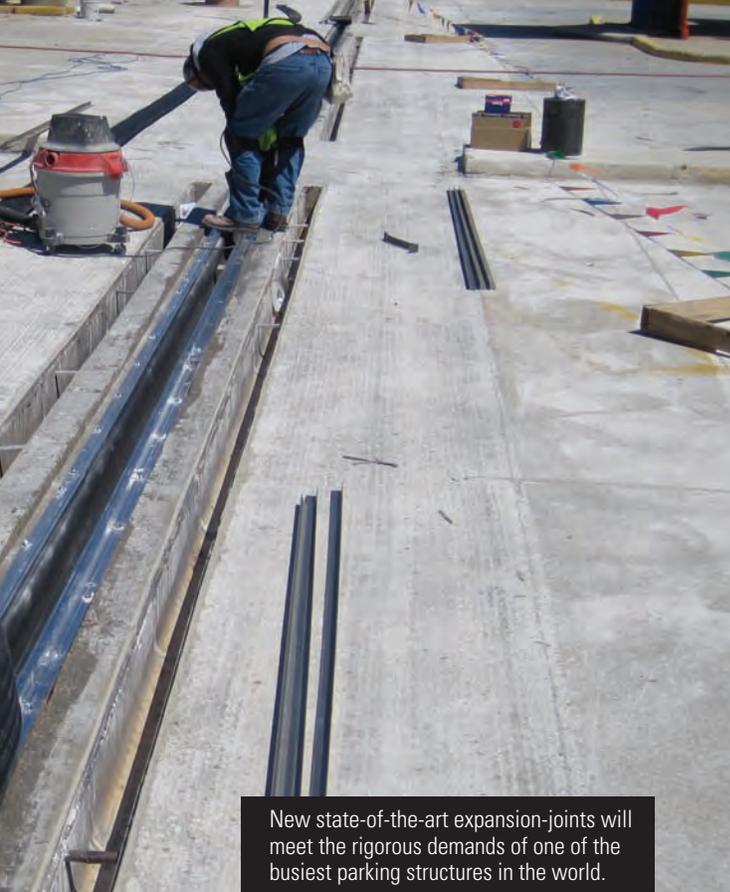
New state-of-the-art expansion-joints will meet the rigorous demands of one of the busiest parking structures in the world.

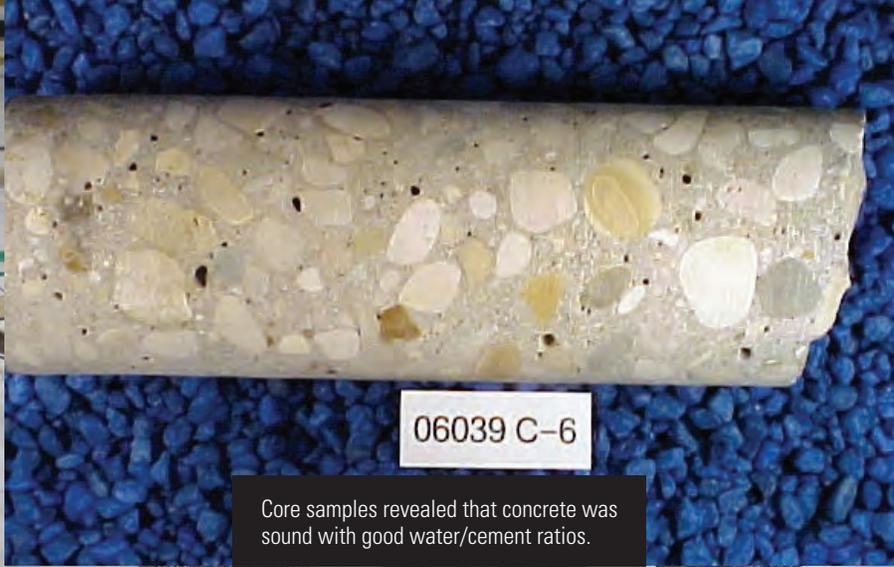
06039 C-6

Crews took eight core samples, and petrographic analysis (see photo, top right, on page 9) revealed that the concrete was of good quality with water/cement ratios ranging from 0.35 to 0.45. Air content ranged from 4 percent to 6 percent, and compressive strengths were 7,710-11,640 psi.

Core samples revealed that concrete was sound with good water/cement ratios.

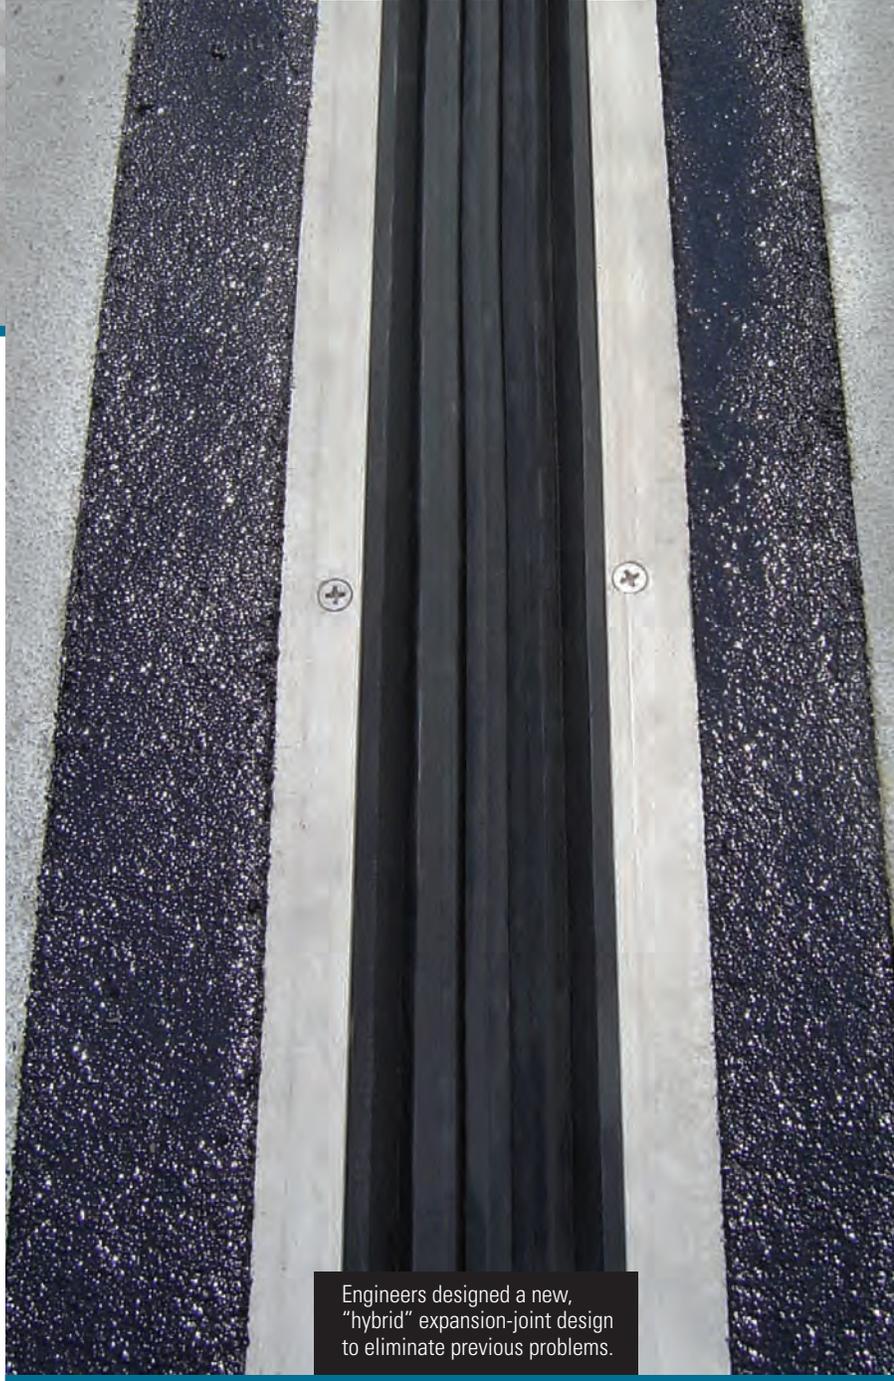
Engineers designed a new, “hybrid” expansion-joint design to eliminate previous problems.

- Multi-directional movement capabilities.
- Continuous, elastoprene rubber seals that could be replaced if damaged.
- A secondary, water-containment, fabric-reinforced, rubber gutter system.
- A structural base frame with a bolted connection to the concrete deck.
- Elastomeric concrete (of polyurethane technology with a blend of aggregates) for use as a shock-absorbing, block out, infill material.
- A pedestrian-friendly, ADA-compliant design.
- A five-year product performance warranty.

Within two months, the teams had engineered, prototyped and manufactured the new “hybrid” expansion-joint design. That quick effort allowed them to install and monitor it over the winter snow-removal season. Based on a yearlong field trial, coupled with previous trials and historical expansion-joint-performance research, they ultimately decided to recommend the new “hybrid expansion joint” to the airport authority with the ultimate goal of substantially curtailing, if not totally eliminating, the seepage of contaminated water through the expansion-joint assembly at the previously identified seepage paths. (See illustration on page 10.)

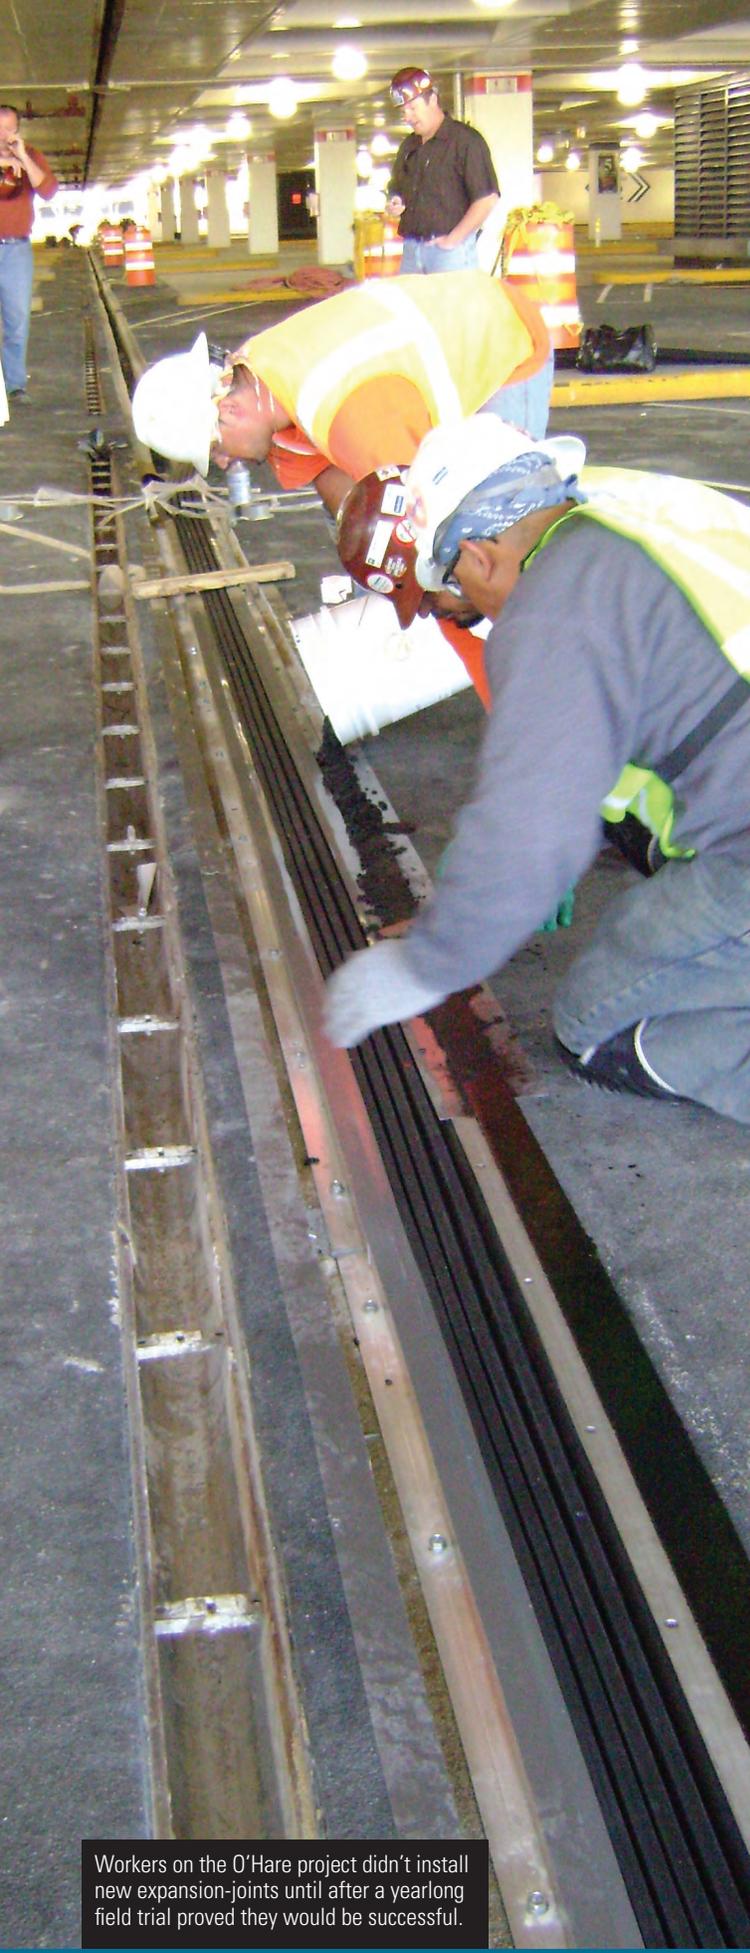
Workers on the O'Hare project didn't install new expansion-joints until after a yearlong field trial proved they would be successful.

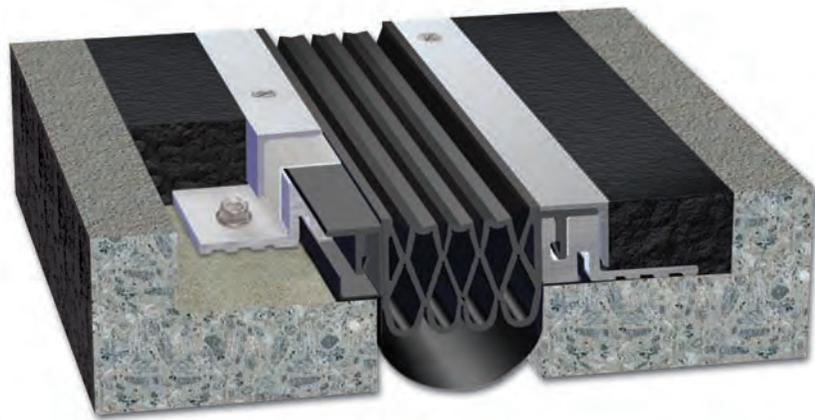
A prototype illustration shows the individual layers of the new "hybrid" expansion-joints.
